Tight rig verification Borgland Dolphin

DNO Norge AS, Wellesley Petroleum AS,
and INEOS E&P Norge AS

AUDITEE Dolphin Drilling/Borgland Dolphin		DATE 12/04/2021	
AUDIT NO. EA-2021-1		REV.NO. 01	
DOCUMENT APPROVAL			
	Name:	Date:	Signature:
Prepared by:	Anniken B. Meisler	06/04/2021	Anniken B. Meisler
	Christina Rødne	06/04/2021	C.S. Rødne
Approved by:	Stig Seland	12/04/2021	Stig Seland

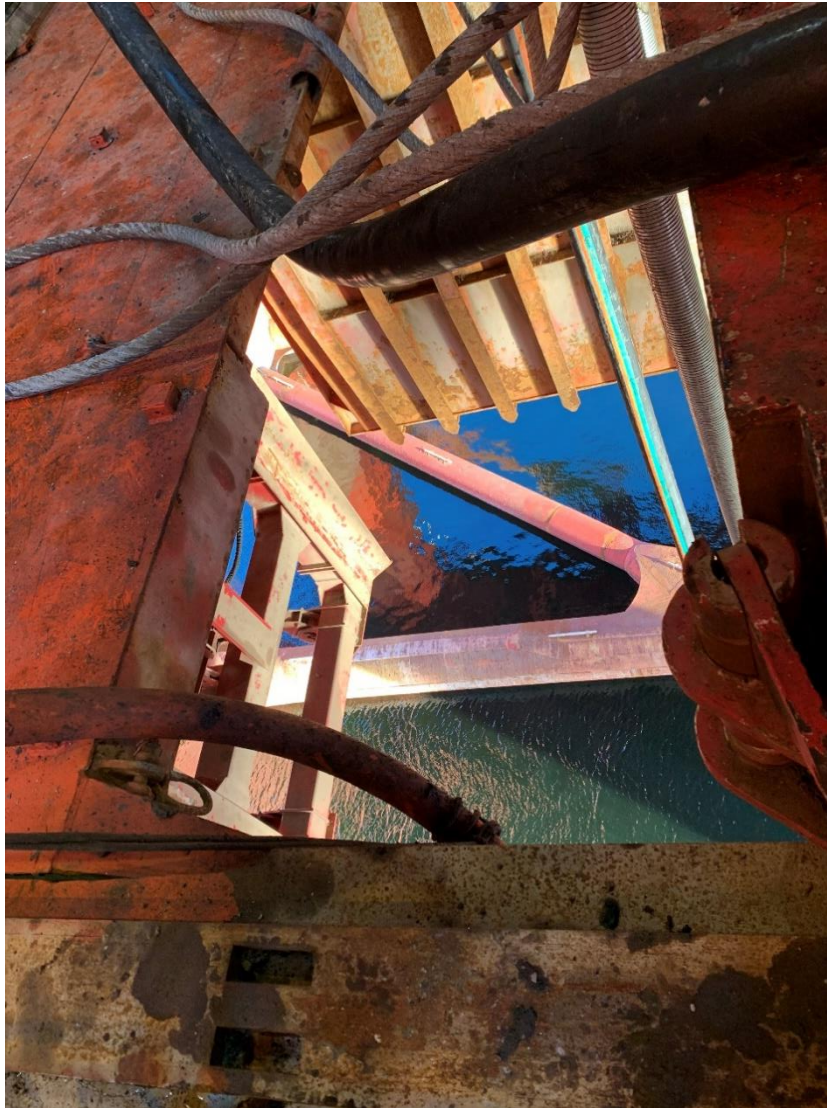
Figure 4-1: UHG seen from above, looking at sea

The general impression among the rig crew was that the chemical used in the Under House Guide (UHG) and riser tensioner – Houghto-Safe NL-1 - is an environmentally friendly glycol. This is a chemical categorized as red.

The verification team recommend to inform relevant crew on this misunderstanding, and BGL to also look for possibilities for substituting this chemical. Any leakages from the UHG (see Figure 4-1) or riser tensioner will go directly to sea, so using a more environmentally friendly alternative would be beneficial. But the most important is the security of rig and equipment, so it is recommended to start the process with securing that this chemical

is included in BGL's substitution plan and then include any information on assessments conducted. Then BGL can document the process and availability of any substitute(s).

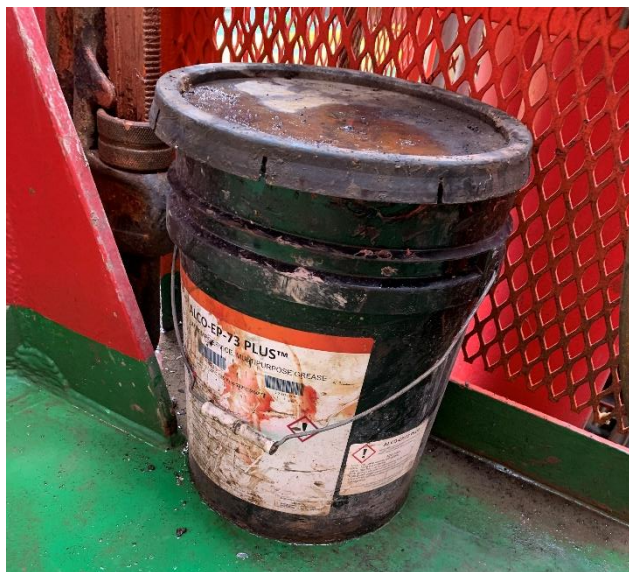
Figure 4-2: Jet-Lube Alco EP 73 Plus

DNO has agreed with Dolphin not to use Jet-Lube Alco EP 73 Plus on the riser, only on BOP, ref. /6/, /8/ and /9/. Going the around on the rig and talking with personnel, it seems like the Jet-Lube Alco EP 73 Plus still is being used on riser. Please ensure that Jet-Lube Alco EP ECF will be used on the riser for the coming operations. And include Jet-Lube Alco EP ECF and Jet-Lube Alco 73 Plus in the monthly reports to operator.

For information Jet-Lube Alco EP 73 Plus is categorized as a red chemical, while Jet-Lube Alco EP ECF is a much more environmentally friendly chemical categorized as yellow (100).

Post verification comment: The environmental poster is finalized and hung up at relevant places onboard BGL.

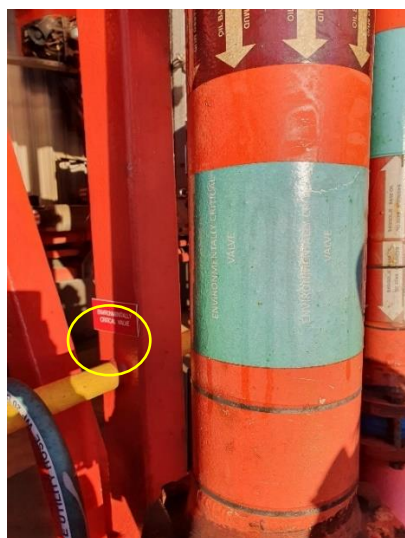
Figure 4-3: Green labels on pipes closed with environmental critical valves. These valves are also marked with red tags (yellow circle)

Environmental Critical Valves (valves going to sea) at both hose stations are marked with green labels in addition to red tags, as shown in

All environmental critical valves shall be marked with red tags. The green labels are confusing and may also lead to the misunderstanding that these are “environmentally friendly”, going to closed systems.

BGL decided that markings should be removed when the verification team was onboard. OIM to please verify that this is done.

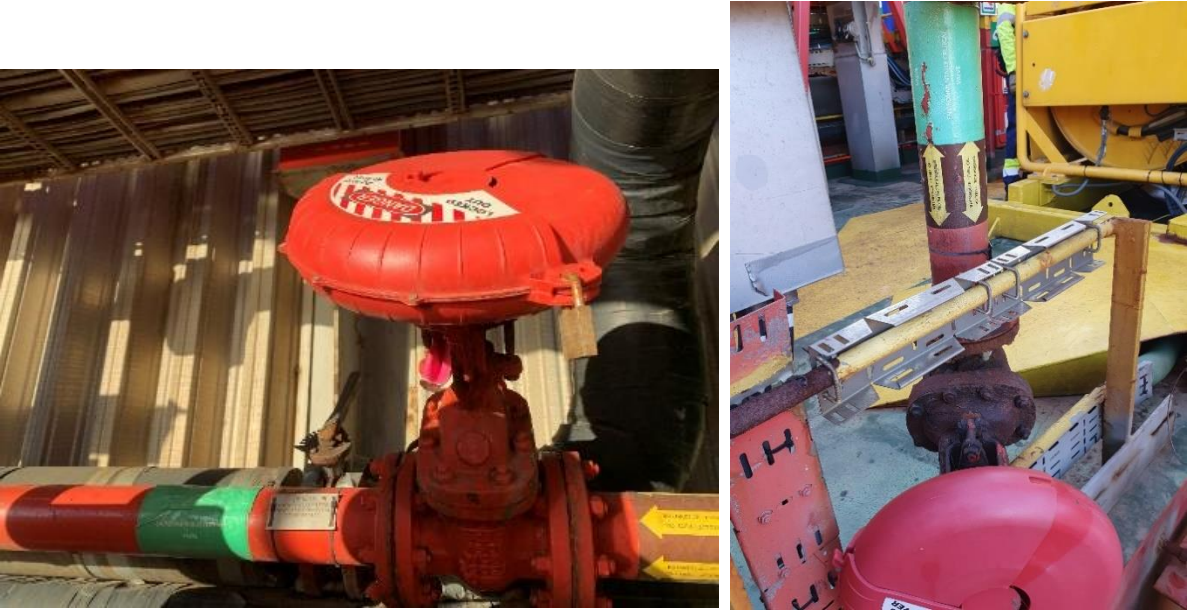
Figure 4-4: Environmental Critical Valves for Fuel oil with green labels, starboard side to the left and port side to the right

Environmental Critical Valves for Fuel oil both on port and starboard side are marked green labels and are missing red tags. Ref. Figure 4-4.

Related to the finding in Ch. 4.4.4, the green labels should be removed, and red tag must be put up.

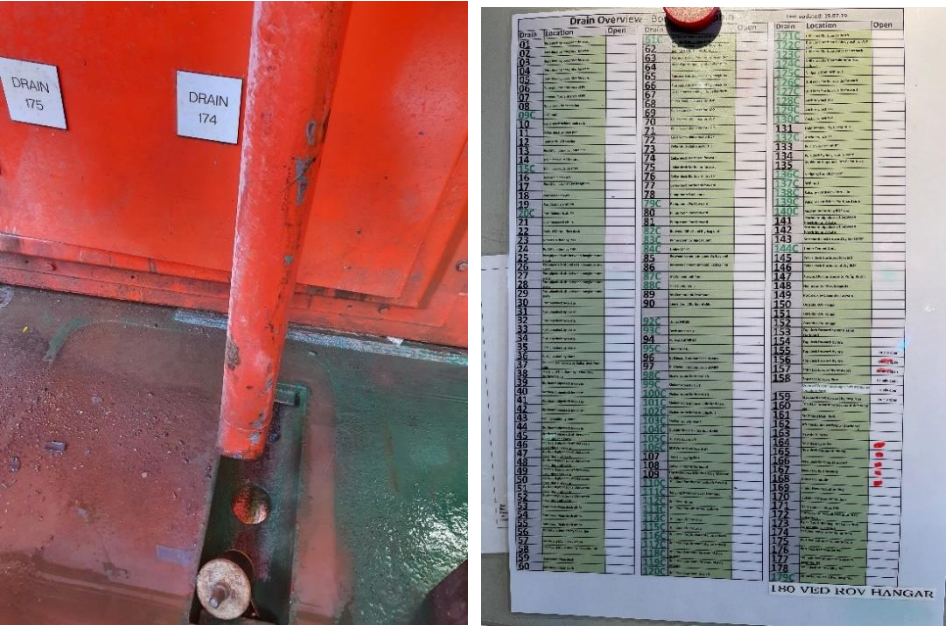
Figure 4-5: Left- open drain #174. Right – Drain overview in Control room. Red dots indicate open drains.

Drain #174 outside pump room was open due to washing, see Figure 4-5. CRO was not informed. This is a deviation from given requirements, ref. /5/. Requirements states that drains can be opened for a short period without informing CRO if person stay by the drain until closed.

Cleaning was ongoing, but no one was seen close to the drain. The verification team contacted the CRO and the drain was not marked as open on the drain overview in Control room (Figure 4-5). The team passed the drain several times during a 4-hour period, and the drain was still open.

If open drains are found without supervision, or not registered as open by the CRO, tends to be a problem, the verification teams suggests that the guideline ST-0104 is changed and no drains can be opened without informing CRO.

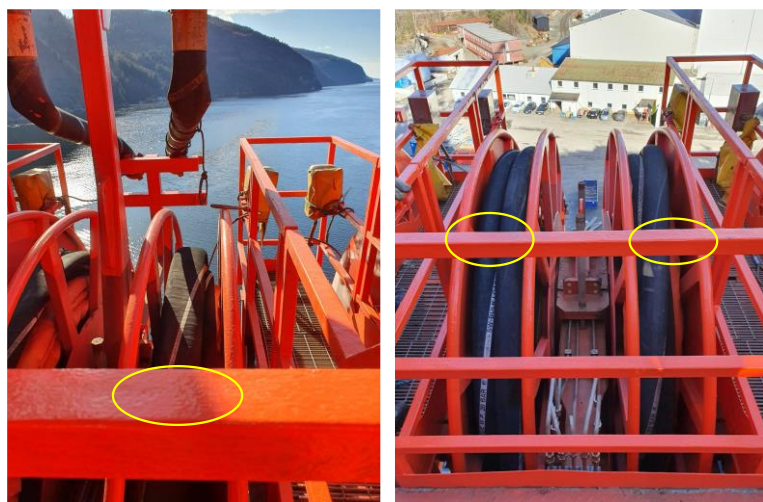
Figure 4-6: Left – Missing label for Fuel oil at starboard hose station. Right - Missing labels for WBM and Brine at port hose station

Some labelling/markings were missing at the hose stations (Figure 4-6). At starboard hose station label were missing by the fuel oil hose, while on port hose station labelling was missing for both WBM and Brine.

It was not particularly easy to follow the hoses further inwards in the rig to see what type of fluid the hoses should load/unload. It is therefore recommended to mark the hose reels so that no misunderstanding or errors can occur.

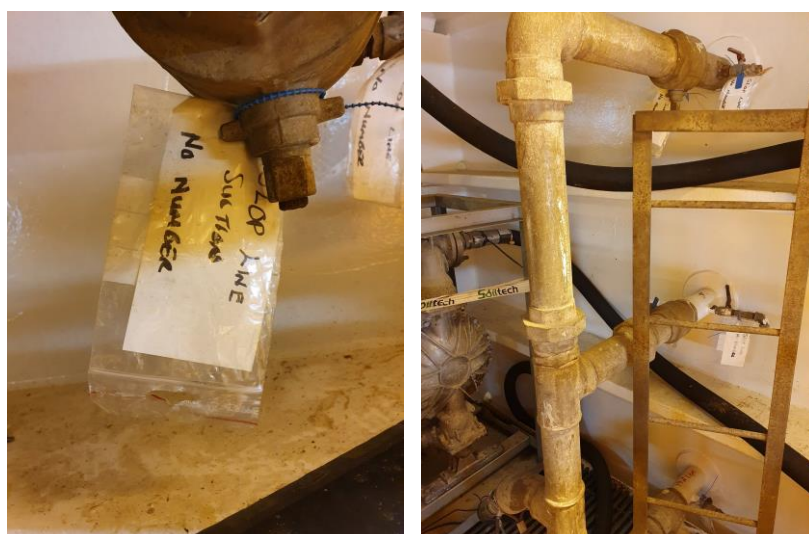
Figure 4-7: Insufficient labelling of pipes in pump room

The pipes going from mud pit #8 to the Soiltech slop treatment unit was not properly marked (Figure 4-7). Home-made tags were put up on the systems. The piping did not look new, so this may have been like this for a long time. The verification team recommend BGL to get the pipes properly marked.

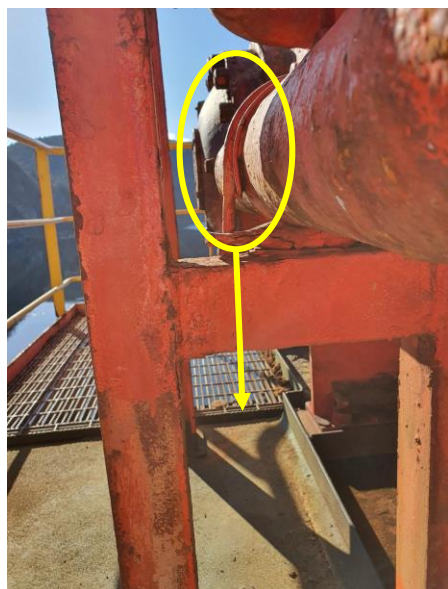
Figure 4-8: Bundling insufficient at anchor winch #3

The bundling is insufficient on left side of anchor winch #3. A potential leakage from the above hydraulic engine for the anchor winch (as shown in Figure 4-8) will not be collected by the underneath bundling. Any leakage from the valve can potentially go to sea.

A solution here may be to extend the bundling, even though the probability for leakage is low.

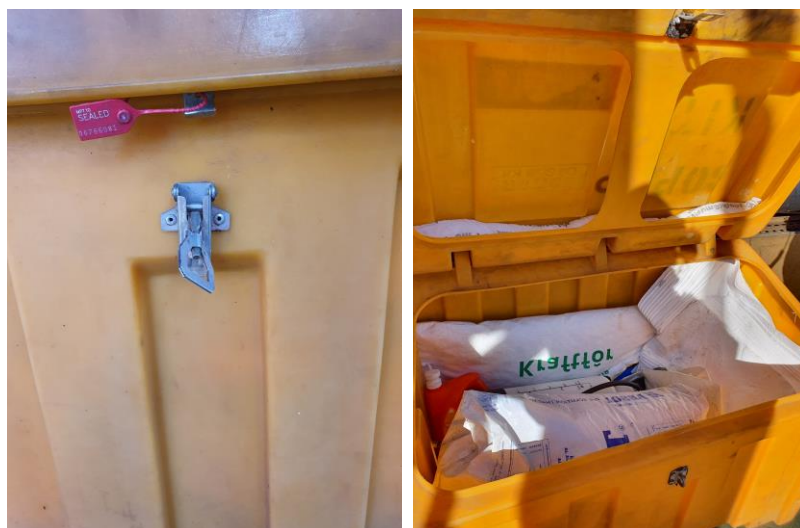
Figure 4-9: Missing sealing (to the left) and inventory list and lacking equipment (right)

An inspection of SOPEP equipment revealed that two of the SOPEP boxes on starboard side missed sealing and one was half full. Inventory lists were also missing in the boxes. See Figure 4-9.

The verification team recommends BGL to go through the open boxes, fill them up with needed equipment, put up Inventory list, and then seal them off. Since there is uncertainty regarding inventory lists in the other four boxes, these should also be checked. This to secure that all expected equipment is available in these boxes.

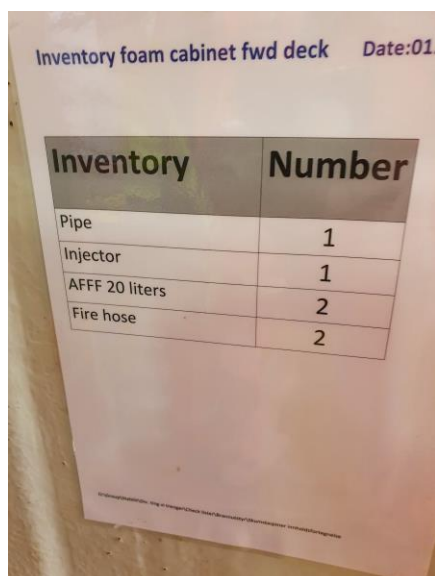
Figure 4-10: Inventory list in foam cabinet on forward deck

The inventory list in the foam cabinet on forward deck - outside the BOP control room - have AFFF foam listed as part of inventory (Figure 4-10). The list should be updated as AFFF foam is not allowed to use on NCS. The AFFF foam was onboard when the rig was operating in UKCS and is no longer onboard.

BGL should also go through all foam cabinets onboard to secure that all lists are up to date.

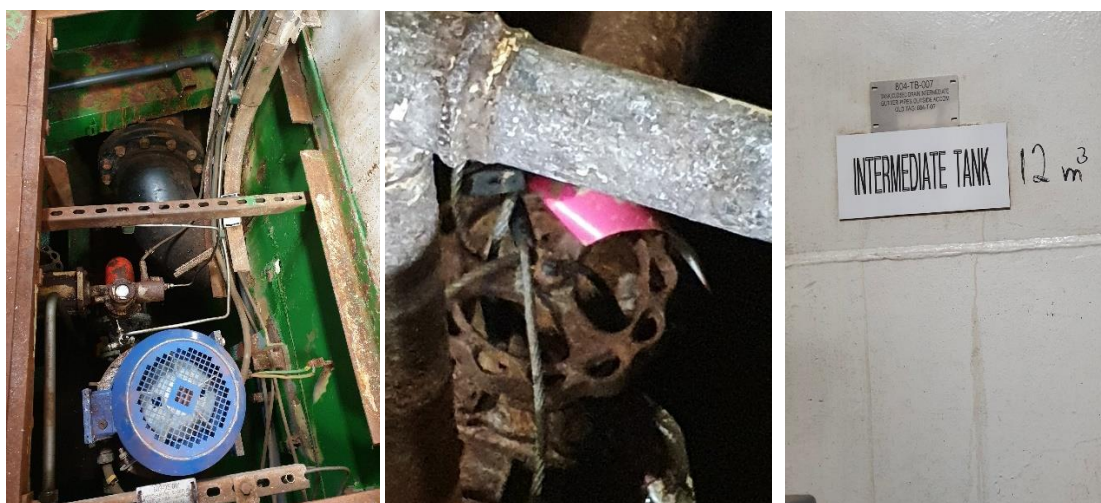
The verification team was guided through the whole bilge system by the MRO, from the bottom of column 4 to overview of the system on CCTV and screens – as shown in the photos series below. The system is rather comprehensive, but very functional and clearly marked. The ppm measuring of bilge water seems robust. Photos from left to right and down shows the electric pump (emergency bilge), environmental critical valve related to bilge, bilge tank, bilge system, ppm measuring instrument, and screen showing bilge tank setup.

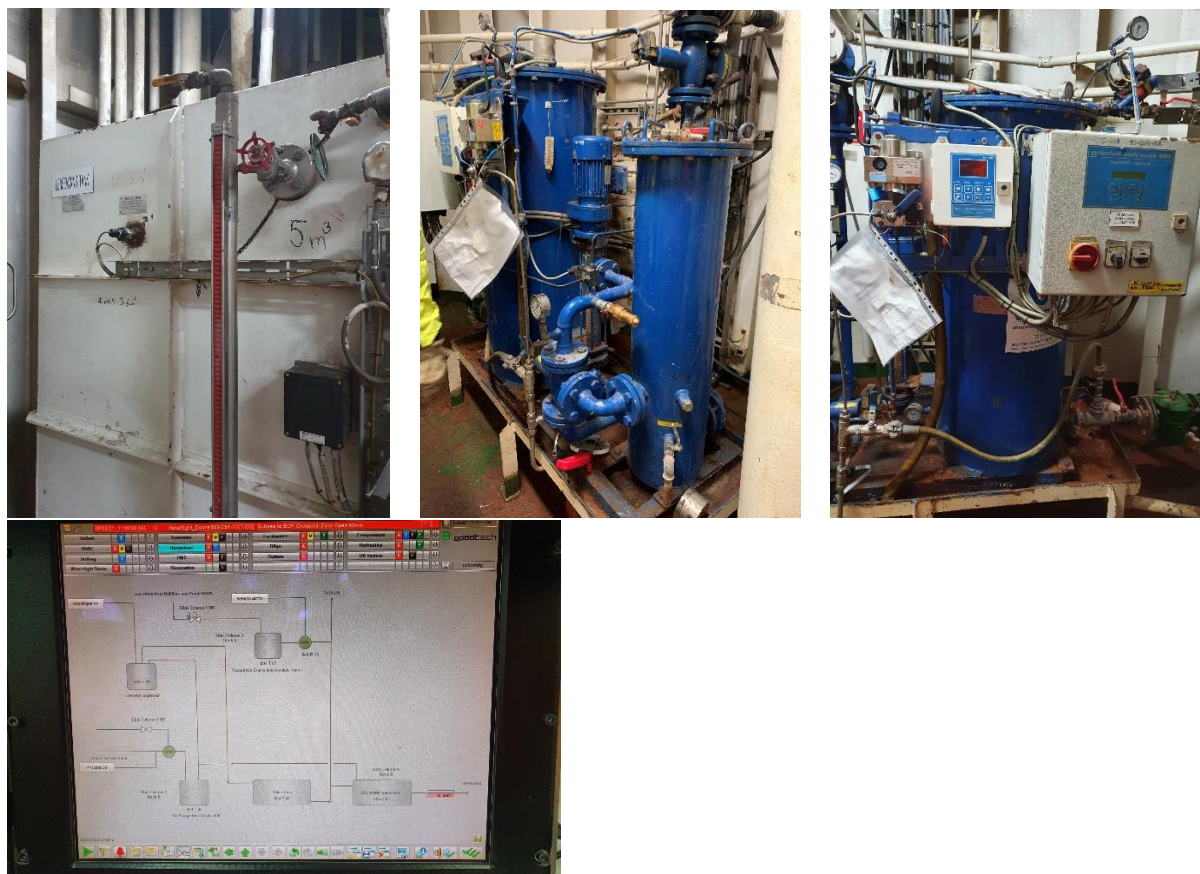
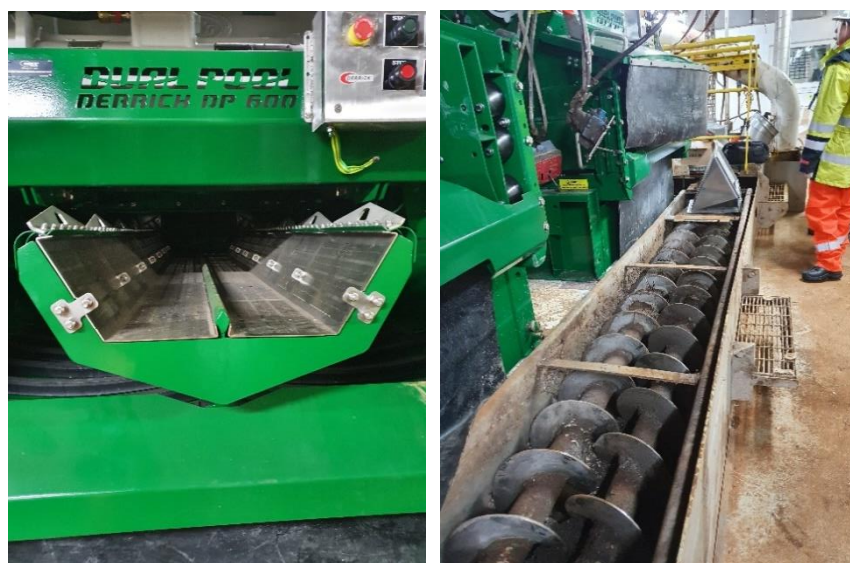
Figure 4-11: One of the new shakers and the whole system

Four new shakers have been installed on BGL (Figure 4-11) with 6 pcs of screens in each that are replaced depending on the operation, and 24 pcs top screens which is mostly dressed with 10 mesh. The new shakers have totally a higher capacity than the five shakers that were previously onboard. Installation of the new shakers also makes room for a screen washer in the shaker room. The verification team hope that DDAS find an efficient washer suitable for the rig as this will effectuate the screen washing and improve the working environment.
