Well Expertise-Rig intake report

JOINT RIG INTAKE REPORT

OSE-DNO-D-RA-0012 RIG INTAKE REPORT

Osellar Decommissioning Project

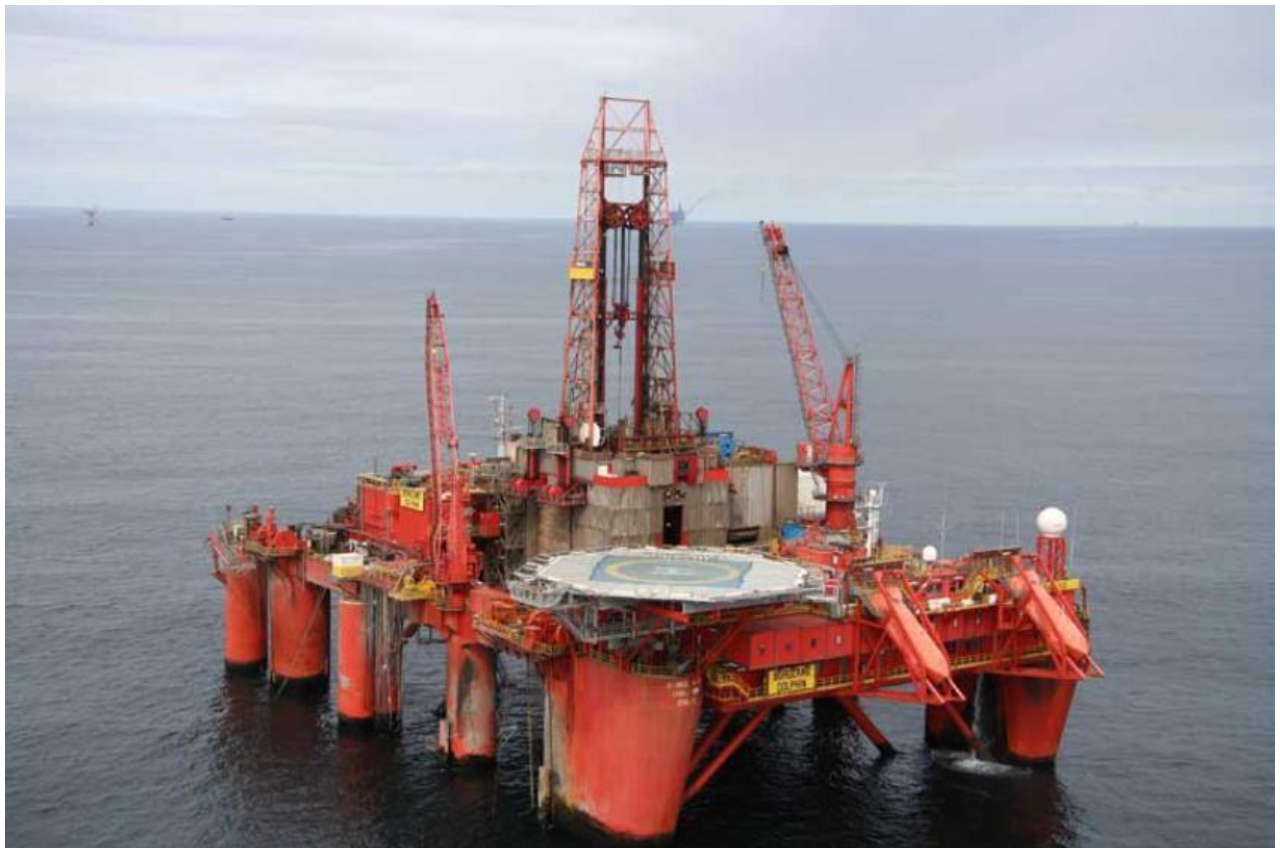
Figure 3-1: Borgland Dolphin

The PP&A and exploration drilling operations will be conducted using the semi-submersible drilling unit Borgland Dolphin operated by DDAS, see Figure 3-1.

Borgland Dolphin is an enhanced Aker H-3 design, 4th generation semi-submersible drilling unit with a 5th generation drilling package. The unit was built in Norway in 1977 as a flotel, had a major upgrade and converted a MODU in 1998/99, and operates under the flag of Bermuda (as of 21.08.20).

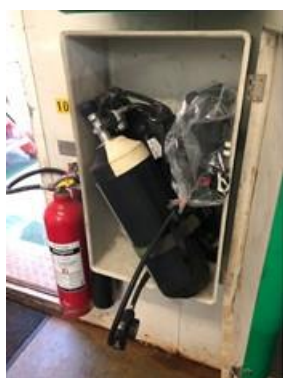
Figure 5-6 Escape masks

One escape mask located in the cupboard (figure 5-6) in the shaker operator room did not have BSS approval sticker on and the PPE for working in an environment with fumes, was dirty and should be better maintained (figure 5-7). Both findings were closed 14.03.2021.

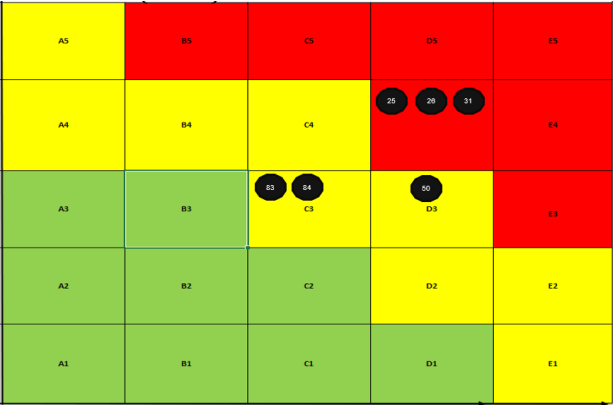
Figure 7-1 Risk Plot (DNO) Initial Risk

As part of the Operational Readiness assessment DNO have carried out a Risk Assessment of the remaining open 3 “High (Red) Nonconformity” and 3 “Medium (Yellow) Nonconformity” findings, based on the status on 18 March 2021:

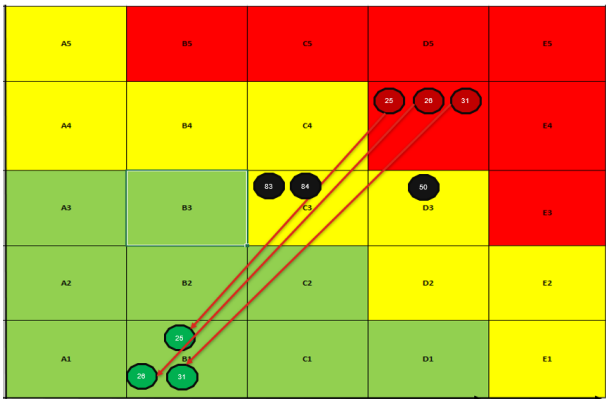
Figure 7-2 Risk Plot (DNO) – Mitigated Risk (Operational Readiness)

After the RA based on input for implemented mitigating actions in to DNO Risk Matrix the current risk status has been accepted and agreed with all involved parties:
