Well Expertise Verification Report

Mitsui Delivery Process – Well Management

AUDITEE						
Mitsui						
AUDIT NO.						
SCHW-WLSLY-S-RA-0618 Verification of Mitsui						
APPROVAL						
Rev. no:	Date:	Auditor:	QA by:	Approved by:	Auditee:	Comments:
01	08.09.20	M. Laget

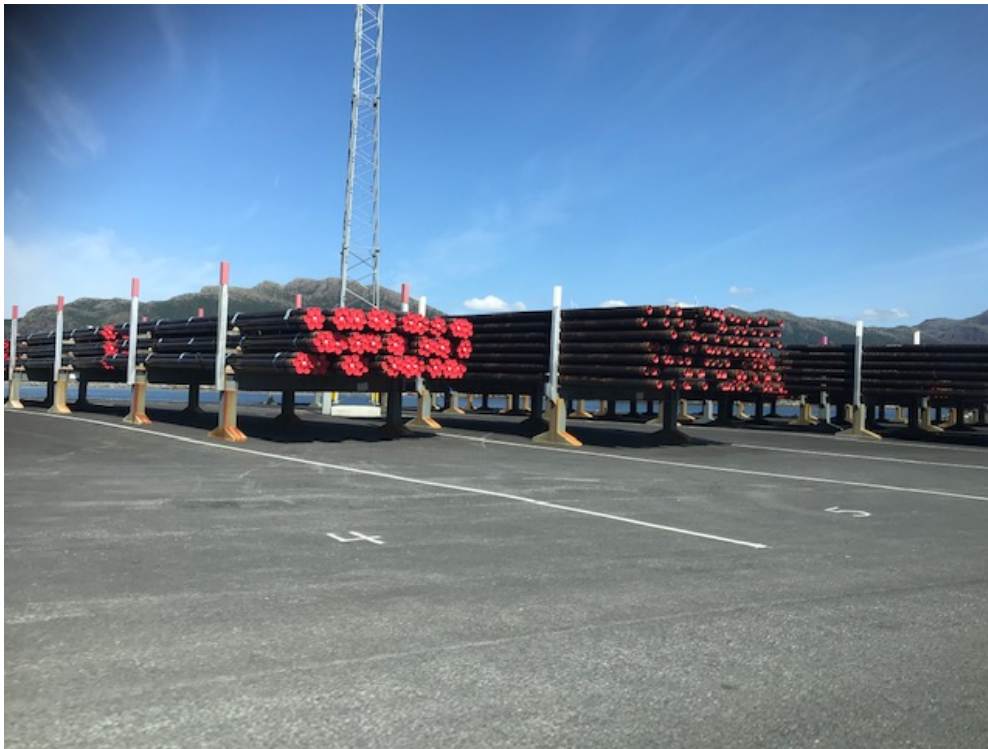
The pipes supplied are new but have been stored for a while at the base. The pipes are stored on H-beams, see picture 1. Below. The pipes are inspected and counted every 6 months by Turboscope, ref. section 14 in the contract. Mitsui has a standard quality plan but have not prepared a specific quality plan for Wellesley according to section 2 in the contract. All pipes come with a certificate that includes:

Picture 1 – Clean and tidy layout and storage areas on base

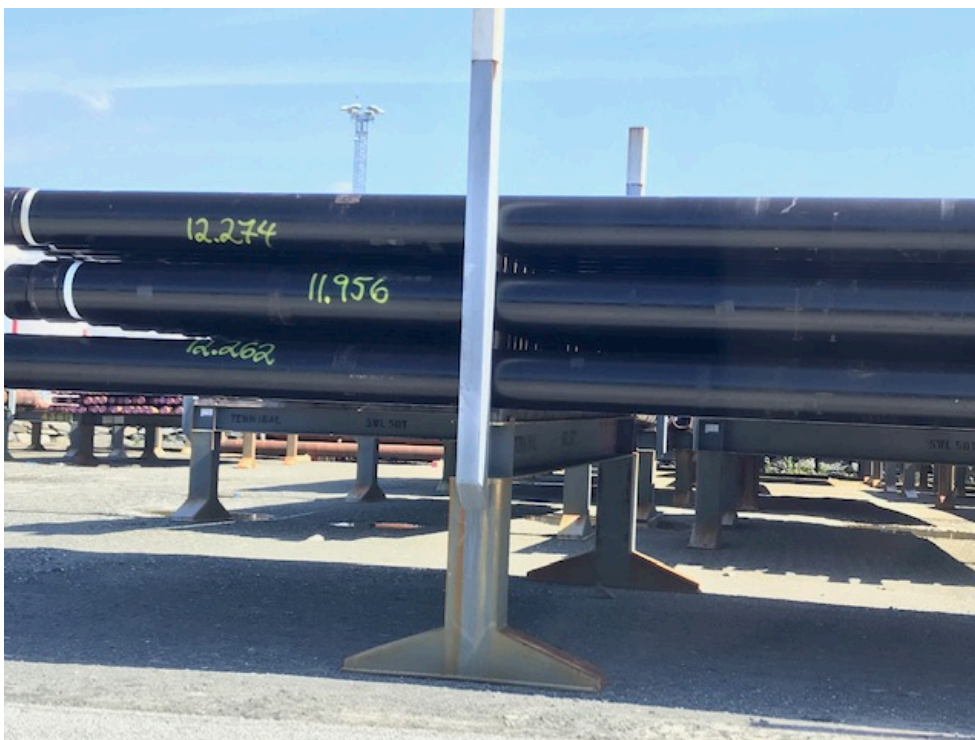
Picture 3 - Wellesley Casing
